Cultural Heritage Impact Assessment

LRD at 42A Parkgate Street,

Blocks A and B2,

Dublin 8

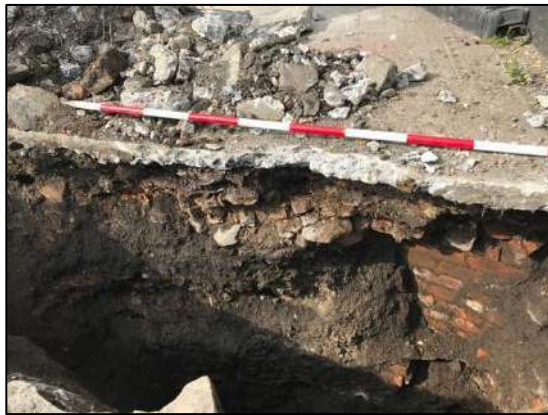
Plate 5 South-facing section of TP102

In the south-facing section, the remains of a redbrick structure were visible (seven courses in height and constructed over a drain) abutting the upstanding structure. This drain was lined with red brick, two courses deep, and capped with a layer of lime mortar. The lime mortar layer was evident across the section and possibly delineates the original ground level when the upstanding structure was constructed. The brown reclamation clays lay directly under this mortar layer.
